# Manhole Inspection Summary

Manhole # S23GG\_049MH

Insp Date: **10/2/07 8:49 AM**

**Location** Address: **1536 WOODYEAR ST**

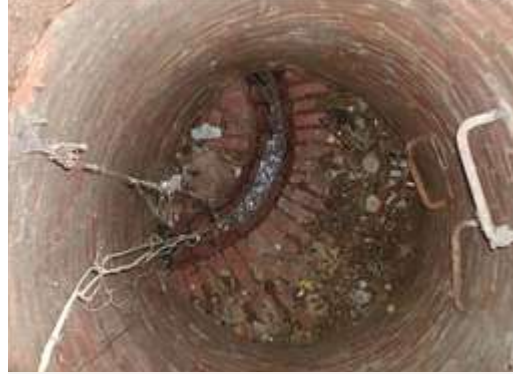
Top View

Corroded steps. Evidence of surcharge - Bench debris.

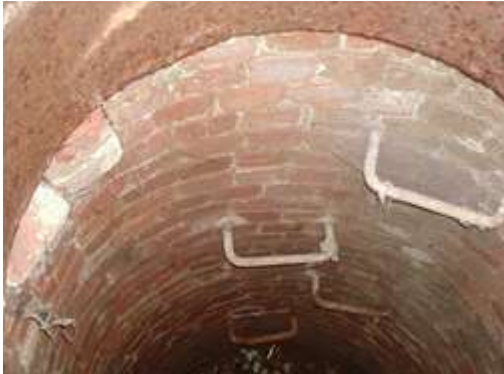
Defect

Frame leaks. Corbel deterioration, root intrusion, loose brick and infiltration. Barrel infiltration.

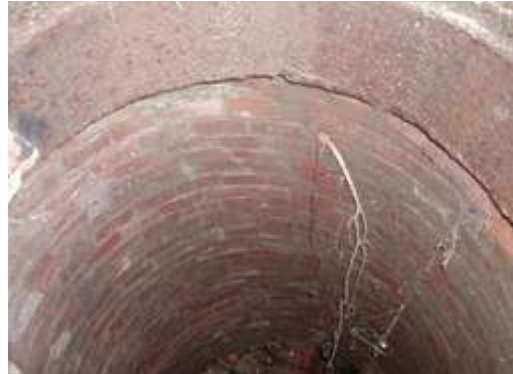
Defect

Frame leaks. Corbel deterioration, root intrusion and infiltration. Barrel infiltration.

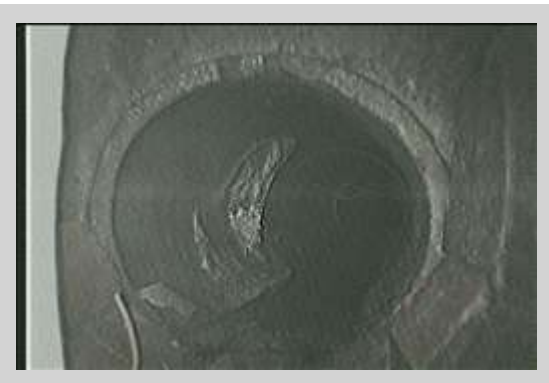
Pipe In @ 9 O'Clock

Infiltration: **Evidence** Pipe Seal Cond: **Cracked**
